# ROYAL MAIL REVIVAL

**Dave Pfeifer, from New South Wales, Australia, is well-versed in Morris Minor saloons, but he decided to take on the challenge of re-creating a Post Office van. He did it, proving that patience and dedication really do pay dividends. He tells the story.**

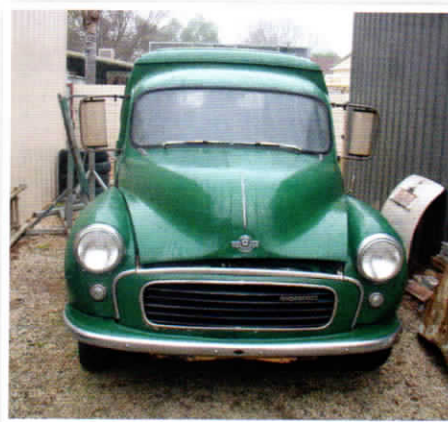
*The Minor van as bought – it looks basically sound, but well-used.*

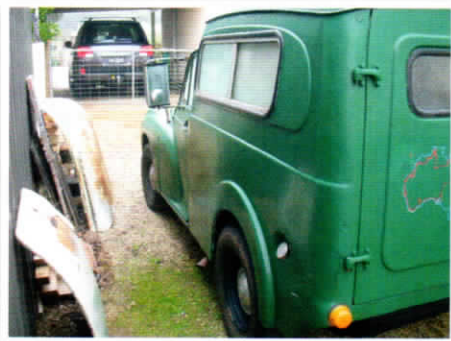
Side windows had been fitted – Dave removed them and welded in new panels.

I removed the van body from the chassis, and the doors and wings, then started on cleaning off the layers of paint on the body. The two side windows had to be taken out and I welded in solid panels. Inside the van, the gutters had quite a bit of rust and I made replacement pieces for both sides and welded them in. It is a lot easier to work on the van body when you can turn it over any way you

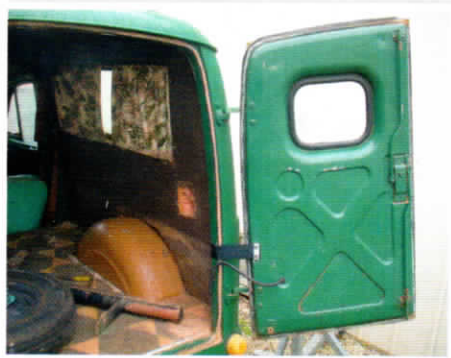
Interior had been lined with plywood – that had to go.

First thing was to totally dismantle the van. I had to remove the plywood lining and the insulation behind it. The dash had many extra gauges and a radio had been cut in above the left hand glove box. There was also a large hole in the firewall above the pedals. On removing the engine and radiator, the damage to the front left side panels was obvious and I had to straighten it out and replace some of the inside wing. The sides of the floor were rusted and I welded new pieces on both sides.

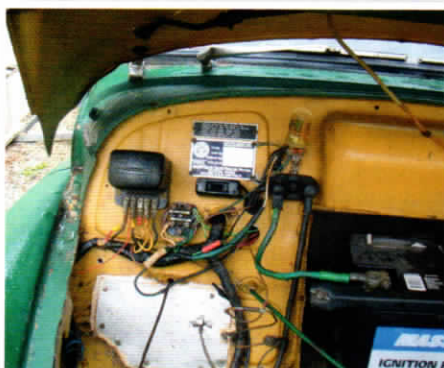
Previous owner had been at work on the bulkhead – using self-tapping screws to hold repair plate in place.

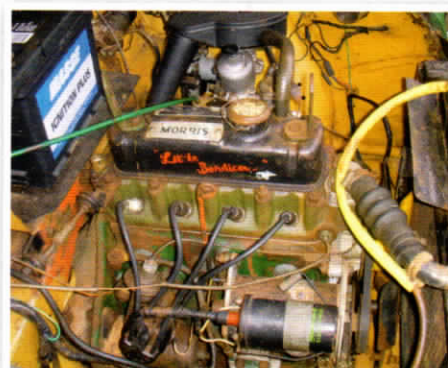
Engine proved to be in quite reasonable condition and fired up without too much trouble.

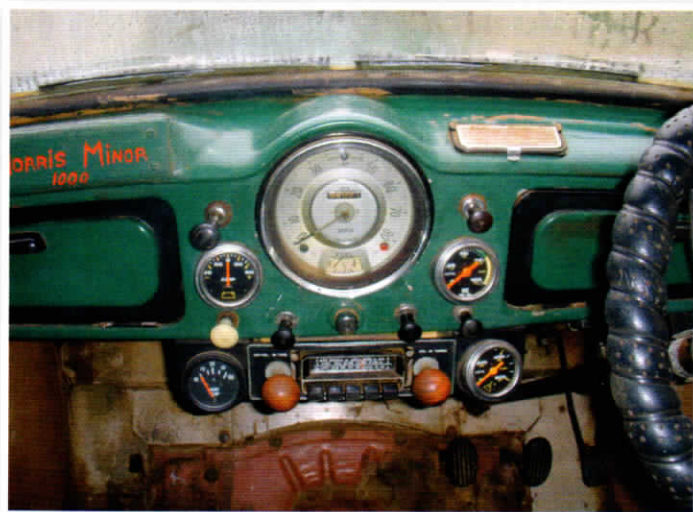
Lots of extra gauges are very handy, but not for a Royal Mail van restoration.

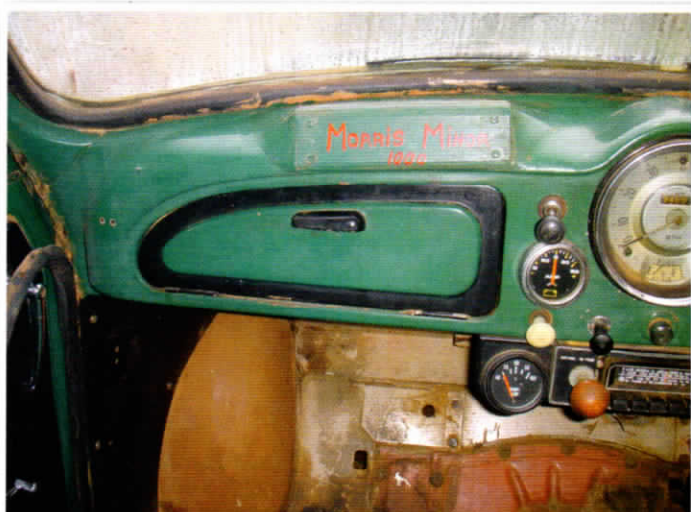
Slot had been cut out of the dash above the glove box to accommodate

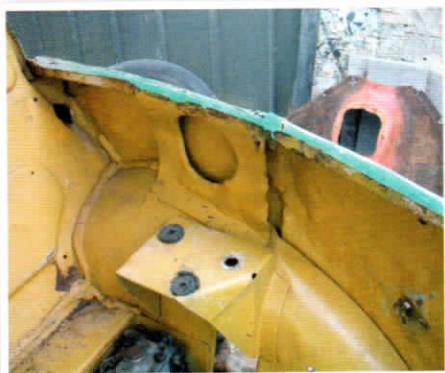
on the engine and brakes for his trip. This made my job a bit easier. However, I found that the van had incurred a pretty bad bang on the front left wing, leaving some damage to the inside panels in the engine bay.

Front nearside wing had taken a knock, which also damaged the inner wing.

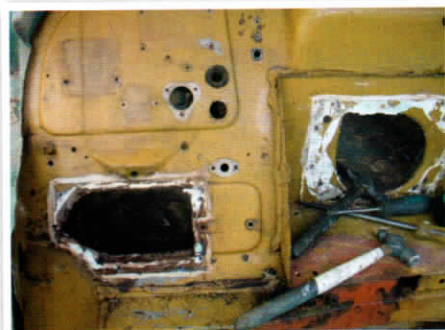
Bulkhead was stripped back so that condition of metal could be fully assessed.

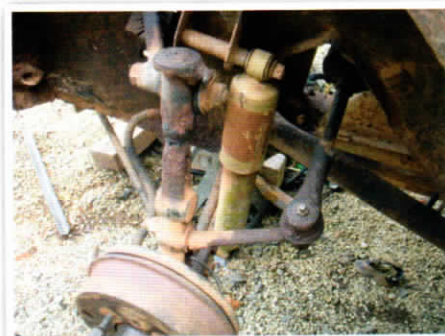
Suspension needed overhauling and returning to original spec.

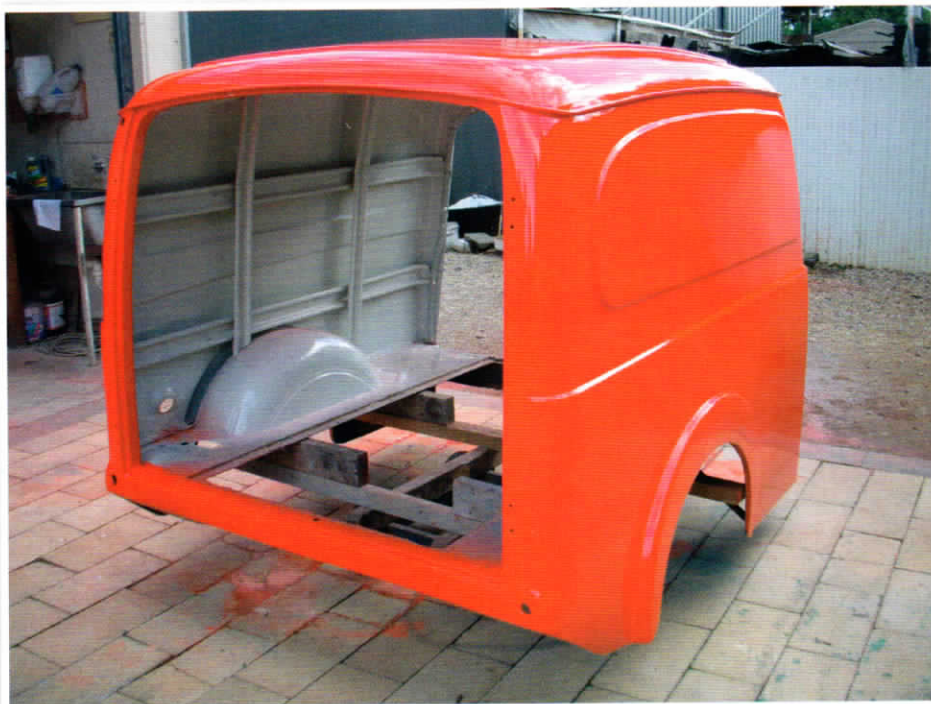
Van body was removed for repairs and paint to be applied.

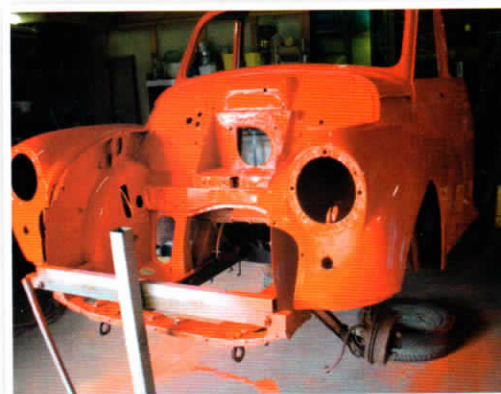
Dave made up his own jig – he calls it a spit – so that the body could be rolled over.

The chassis, complete with the cabin, was bolted to my home-made jig, so that they could be rotated 90 degrees to work on the underside. I left the torsion bars and front end connected, but cleaned it all to find that a lot of work had been done in that area before the round-Australia trip and all was still good. There was a lot of red mud caked on

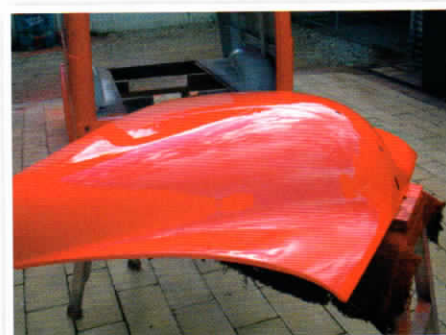
Bonnet has been painted and the finish is looking good.

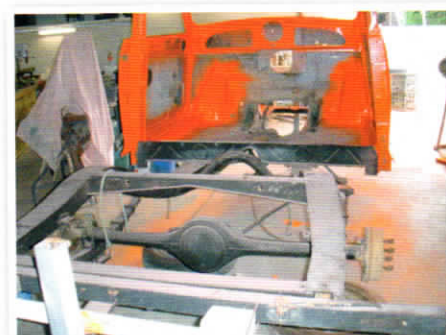
Chassis was found to be in generally good

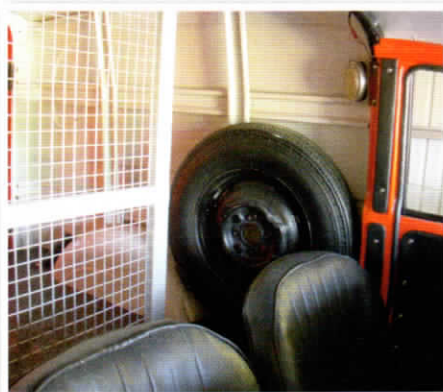
Van has all of the correct fittings, such as grille that separates driver from load area.

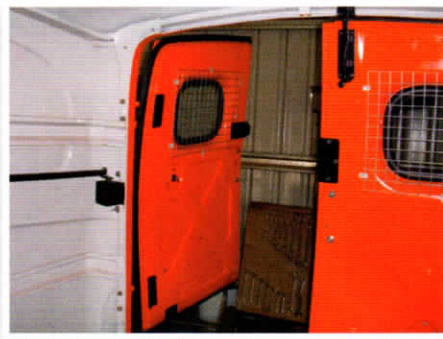
Locks on rear doors are as Royal Mail had them fitted.

On reassembling the van with all new rubbers, I then started to fabricate the special bits that made it a Royal Mail van, such as the inside covers on the hinges of the back door, the Yale-type locks on each side door and the back door and the bar-locking system on the outside of the back doors. These made it more difficult to break into the van when it was in service. I met a chap who actually drove a Royal Mail van for the Post Office and he explained to me how three men would take the van to pick up £20,000 from the bank and sort it out in the back to deliver various amounts of cash to each Post Office in their area.
